RESEARCH MEMORANDUM

LATERAL AND DIRECTIONAL STABILITY AND CONTROL
CHARACTERISTICS OF A C-54D AIRPLANE

Donald B. Talmage and John P. Reeder

March 24, 1949

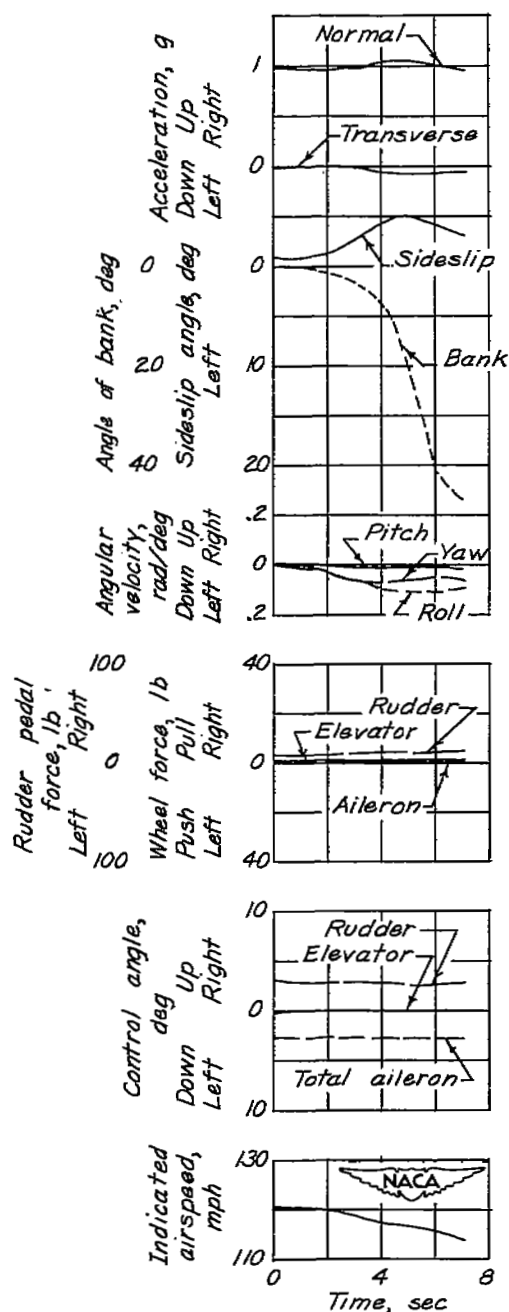
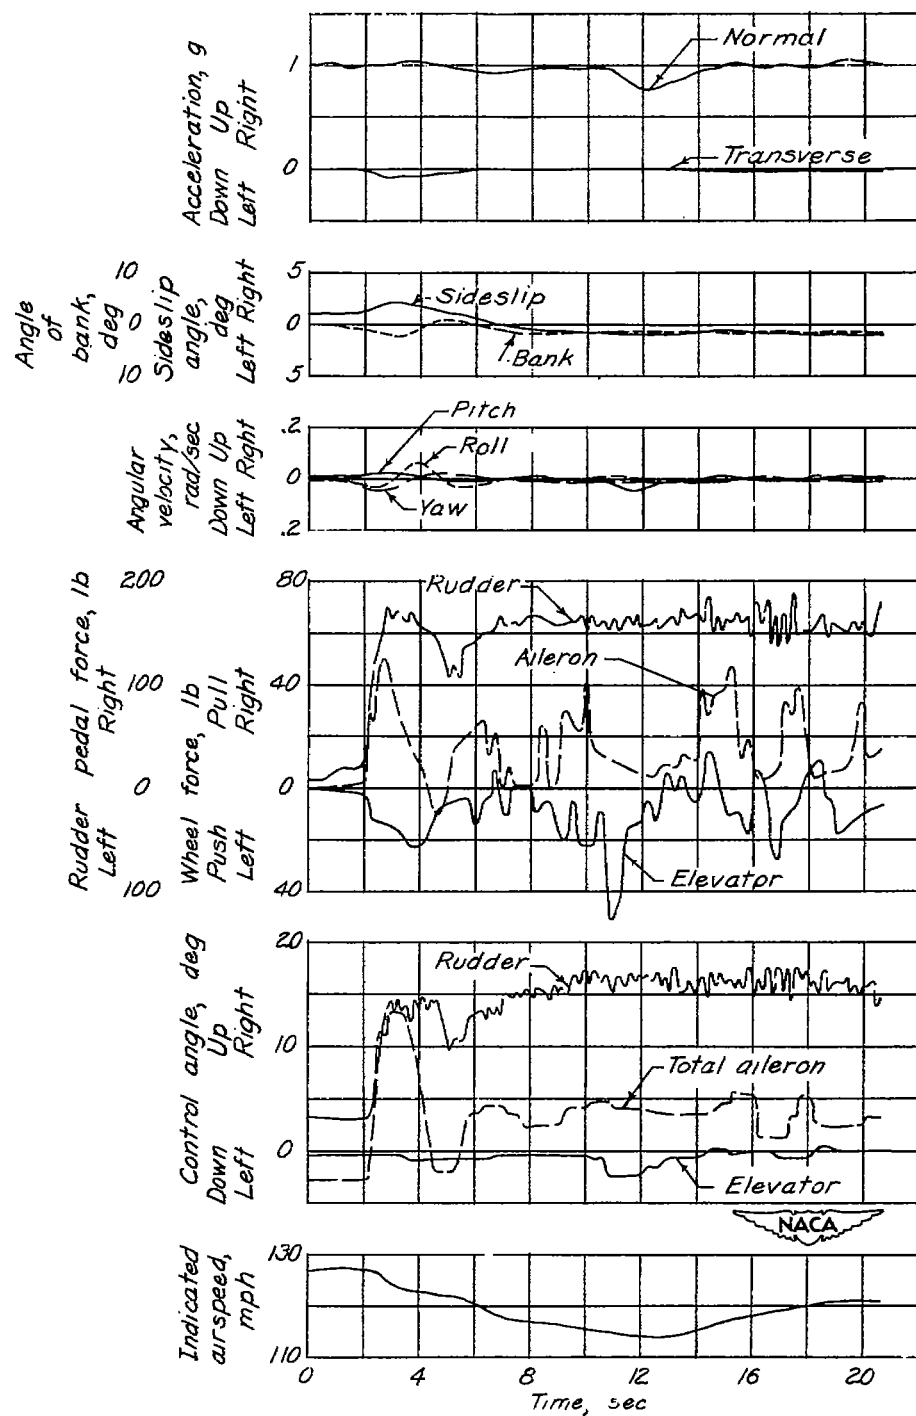
Figure 18.— Time histories of airplane motions during a simulated take-off in which No. 1 engine fails. C-54D airplane; flaps 20°; gear down; power 43 in. Hg; 2550 rpm; No. 1 engine cut to idling.

Uncontrolled attitude changes due to asymmetric power.— At the request of the Airplane Handling Qualities Subcommittee of the Air Transport Association special tests were run to determine the time it would take to reach a dangerous attitude if no corrective control were applied upon the complete loss of power of the most critical engine. Records were taken of the airplane motions and the control angles and forces during the simulated loss of number 1 engine (left outboard). Time histories of these maneuvers in both the take-off and wave-off condition with and without corrective control are presented in figures 17 and 18. The angle of bank presented was obtained from an integration of the record of the rolling velocity. The sideslip angle remained small throughout the maneuver and consequently the rapid deviation from the straight and level flight path associated with large angles of sideslip did not appear. The time to reach a dangerous

attitude was about 7 seconds in the take-off condition and longer in the wave-off condition. It is felt that 7 seconds is sufficient time for the pilot to cope with the emergency and be able to recover with ease.

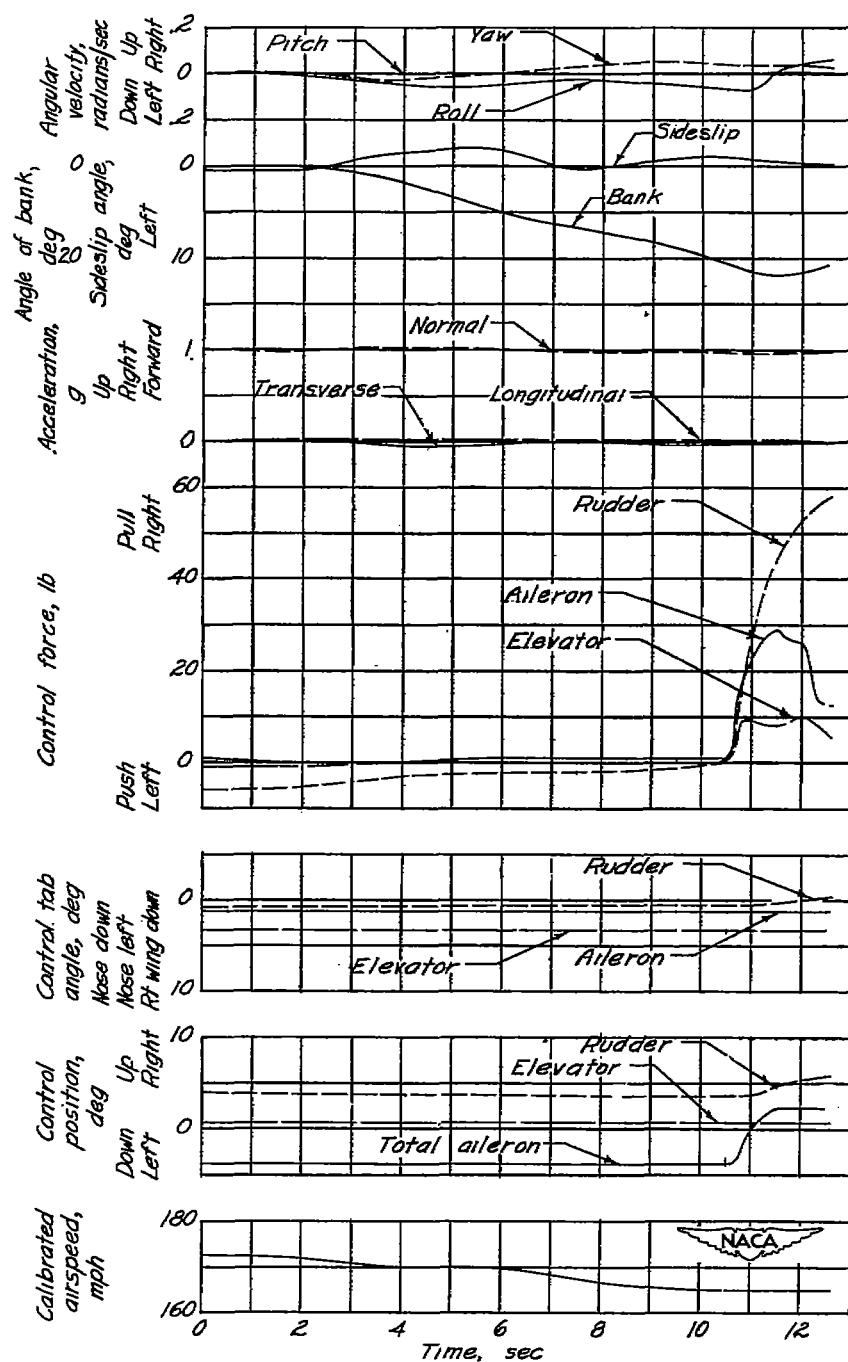
Figure 19.—Time history of airplane motions after loss of power on No. 1 engine in the cruise condition. C-54D airplane; clean power for level flight before No. 1 engine cut to idling at start of record; corrective control started at 10.5 seconds.

A record was also taken in the cruising condition (clean, power for level flight at the speed for maximum range) to determine the uncontrolled motions of the airplane. A time history of the motions of the airplane is presented in figure 19. The rolling moment can easily be counteracted by the ailerons and the yawing moment is quite small. Therefore, the airplane could be balanced in straight flight with rudder free by banking and sideslipping.

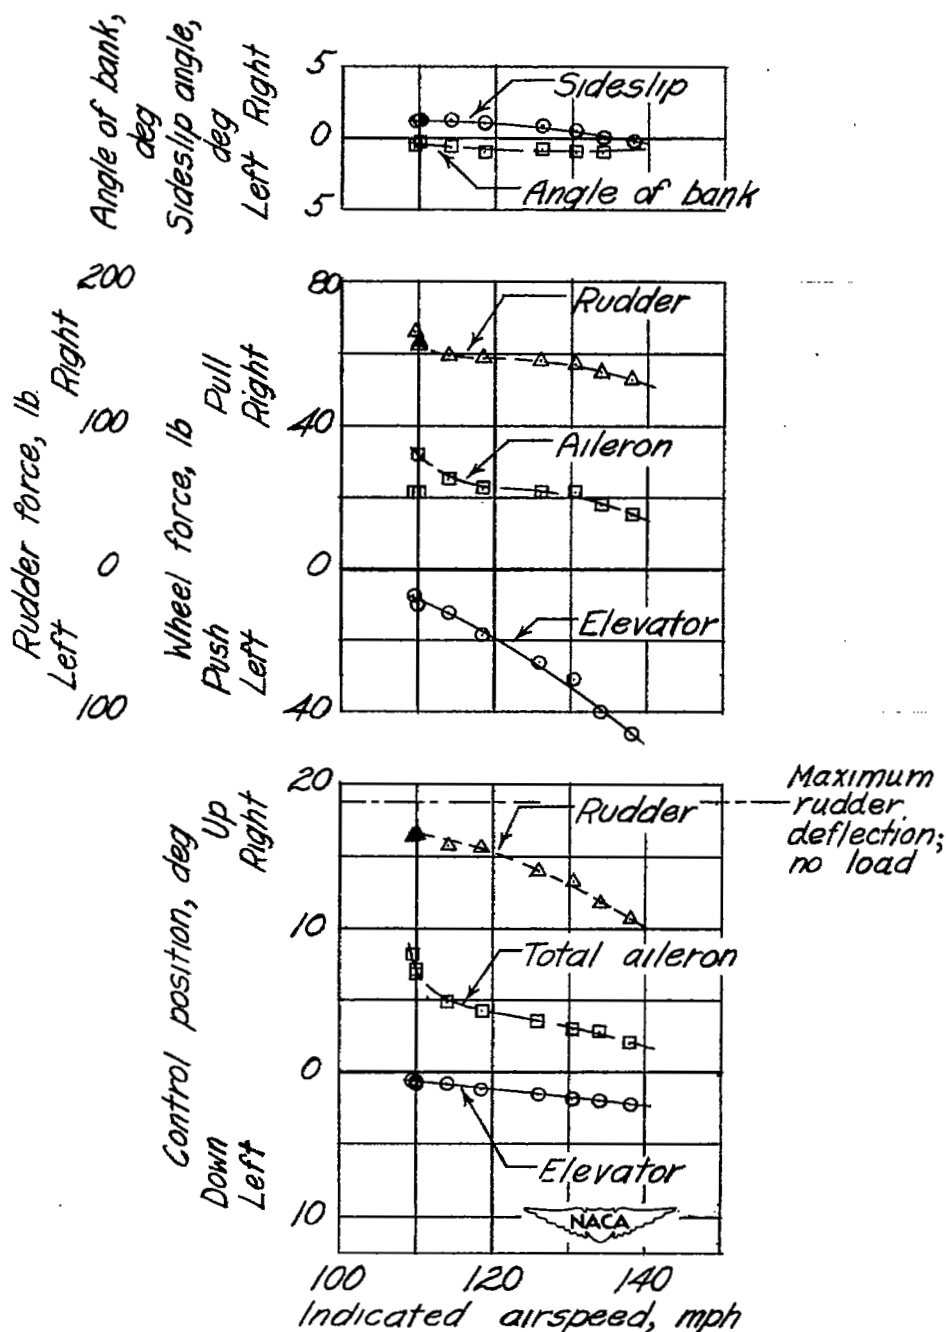
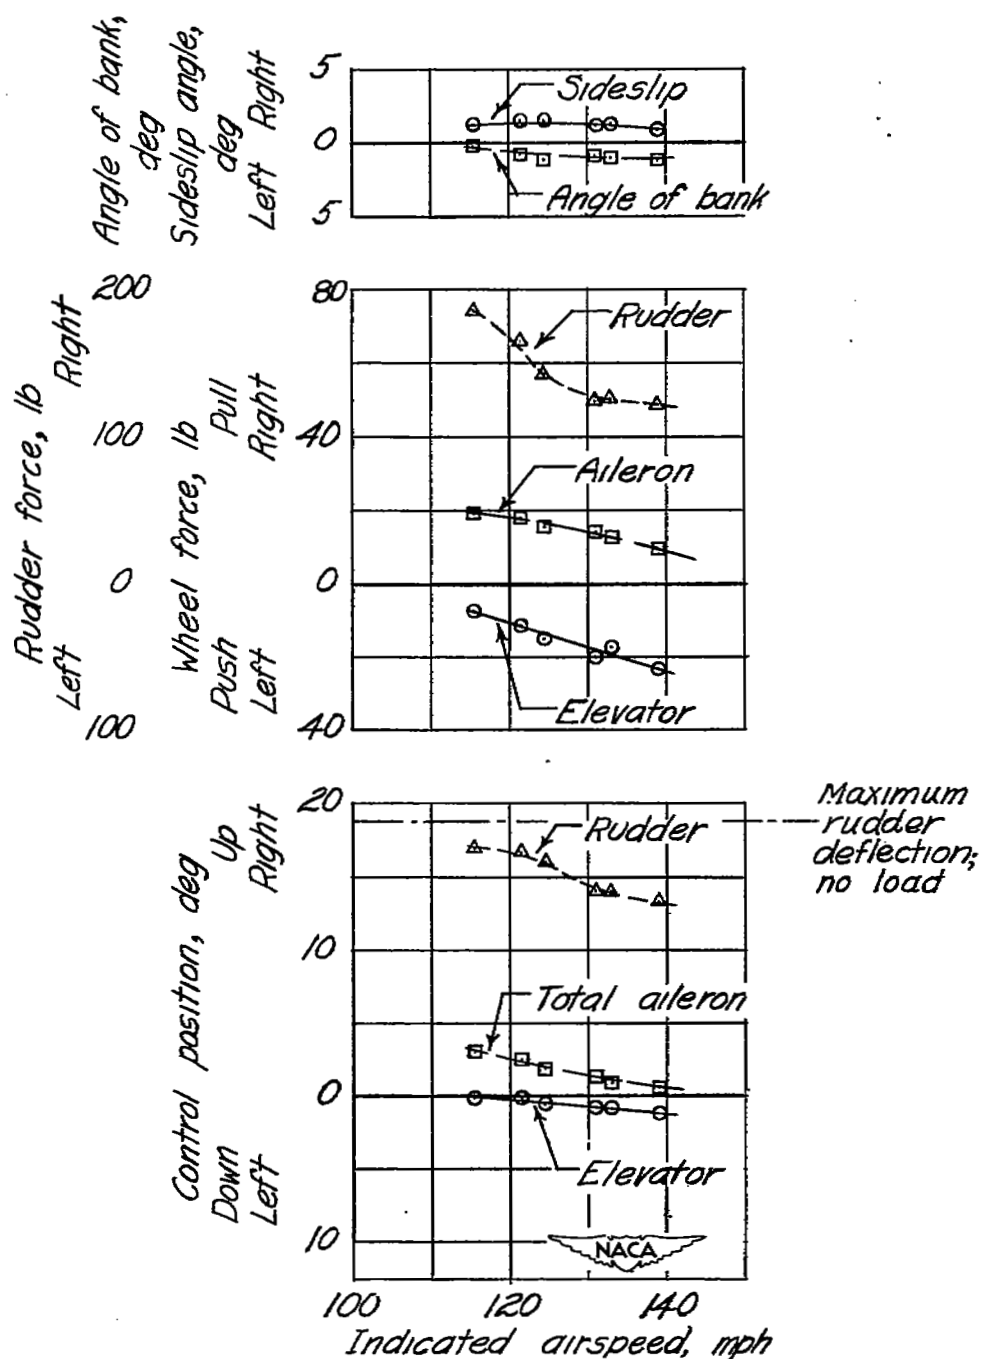
Figure 20.— Lateral and longitudinal trim characteristics with asymmetric power. C-54D airplane.

Directional control power.— Tests were made in simulated asymmetric power conditions to determine the minimum speed at which the airplane could still fly with zero sideslip. These tests were made in the take-off and wave-off conditions with the most critical engine (no. 1) idling and the remaining three engines delivering full take-off power. Spot records were taken in steady straight flight at decreasing airspeed until the full rudder control was used. The directional characteristics during the asymmetric power operation in the take-off and the wave-off conditions are presented in figure 20. The speeds at which the rudder pedals reached their stops were 109 miles per hour in the wave-off condition and 115 miles per hour in the take-off condition. The stalling speeds with power off were 87 and 96 miles per hour, respectively, at approximately 54,000 pounds and would be higher with the normal gross load. In the take-off condition, then, the requirement that the rudder be able to hold zero sideslip at all speeds above 1.2 times the stalling speed with power off is met. In the wave-off condition, the lowest speed reached was 5 miles per hour higher than 1.2 times the stalling speed with power off, but there is no requirement for this condition even though it is usually a more critical condition.

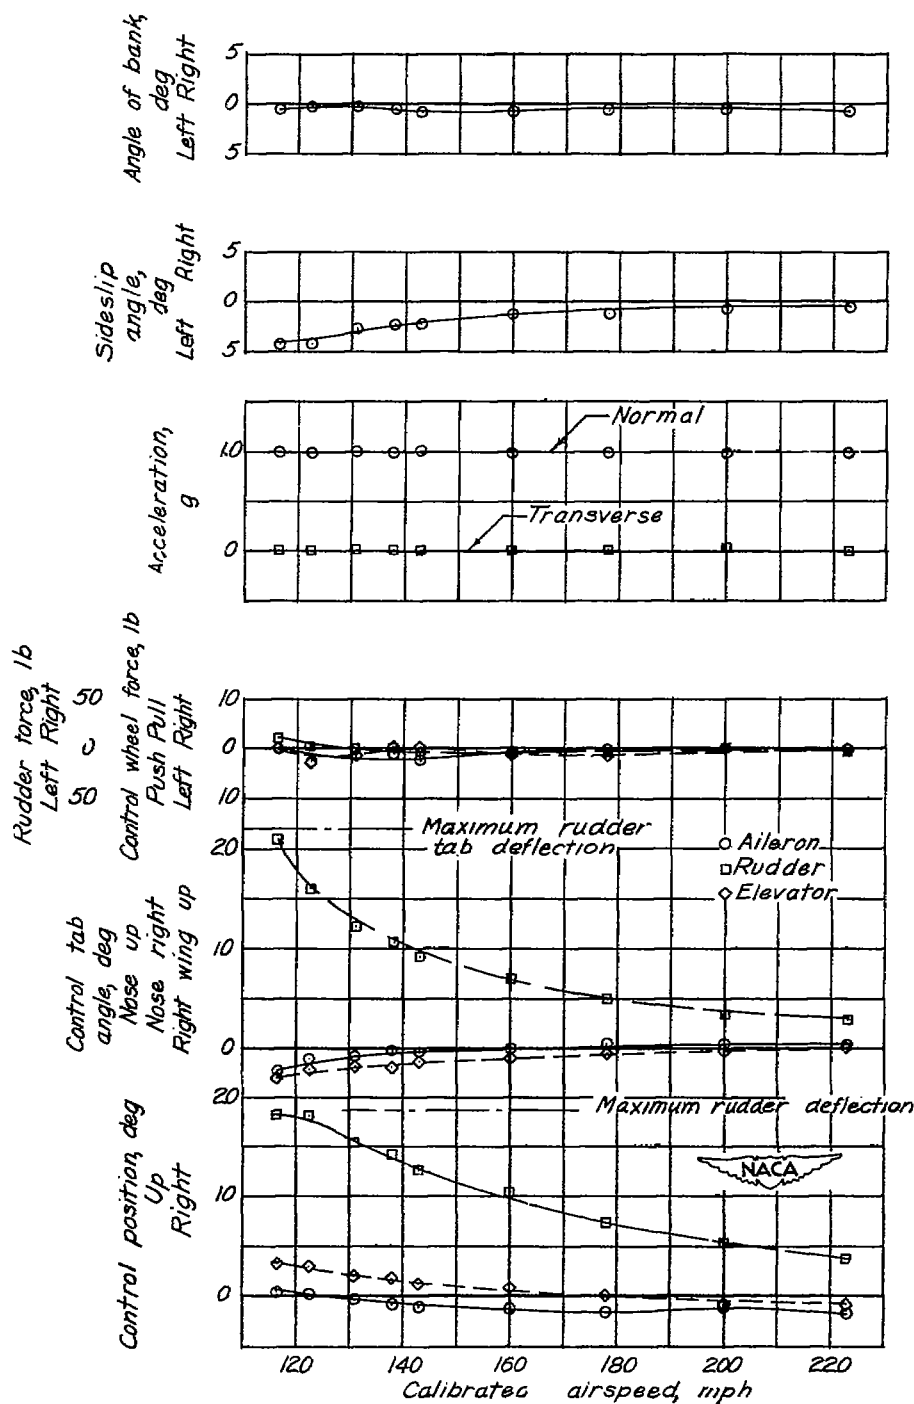
Figure 21.— Lateral and longitudinal trim characteristics with asymmetric power; trim with trim tabs; C-54D airplane. Clean condition; power; No. 1 engine idling; No. 2, 3, and 4 normal rated power.

Lateral and directional trim devices.— The ability of the trim tabs to trim the forces to zero throughout the speed range in the cruising condition (clean, power for level flight at speed for maximum range) with number 1 engine idling is presented in figure 21. The trim tabs are sufficiently

powerful to trim the control forces to zero down to a speed of 116 miles per hour with one engine idling. The condition with both number 1 and number 2 engines idling was not tested. However, since number 2 engine would produce less yawing moment than number 1 with equal power, to trim the airplane directionally with both number 1 and number 2 engines idling would require less than twice the tab deflection. From figure 21 the lowest speed at which twice the rudder tab deflection would be obtained without exceeding the maximum tab deflection available would be approximately 140 miles per hour.

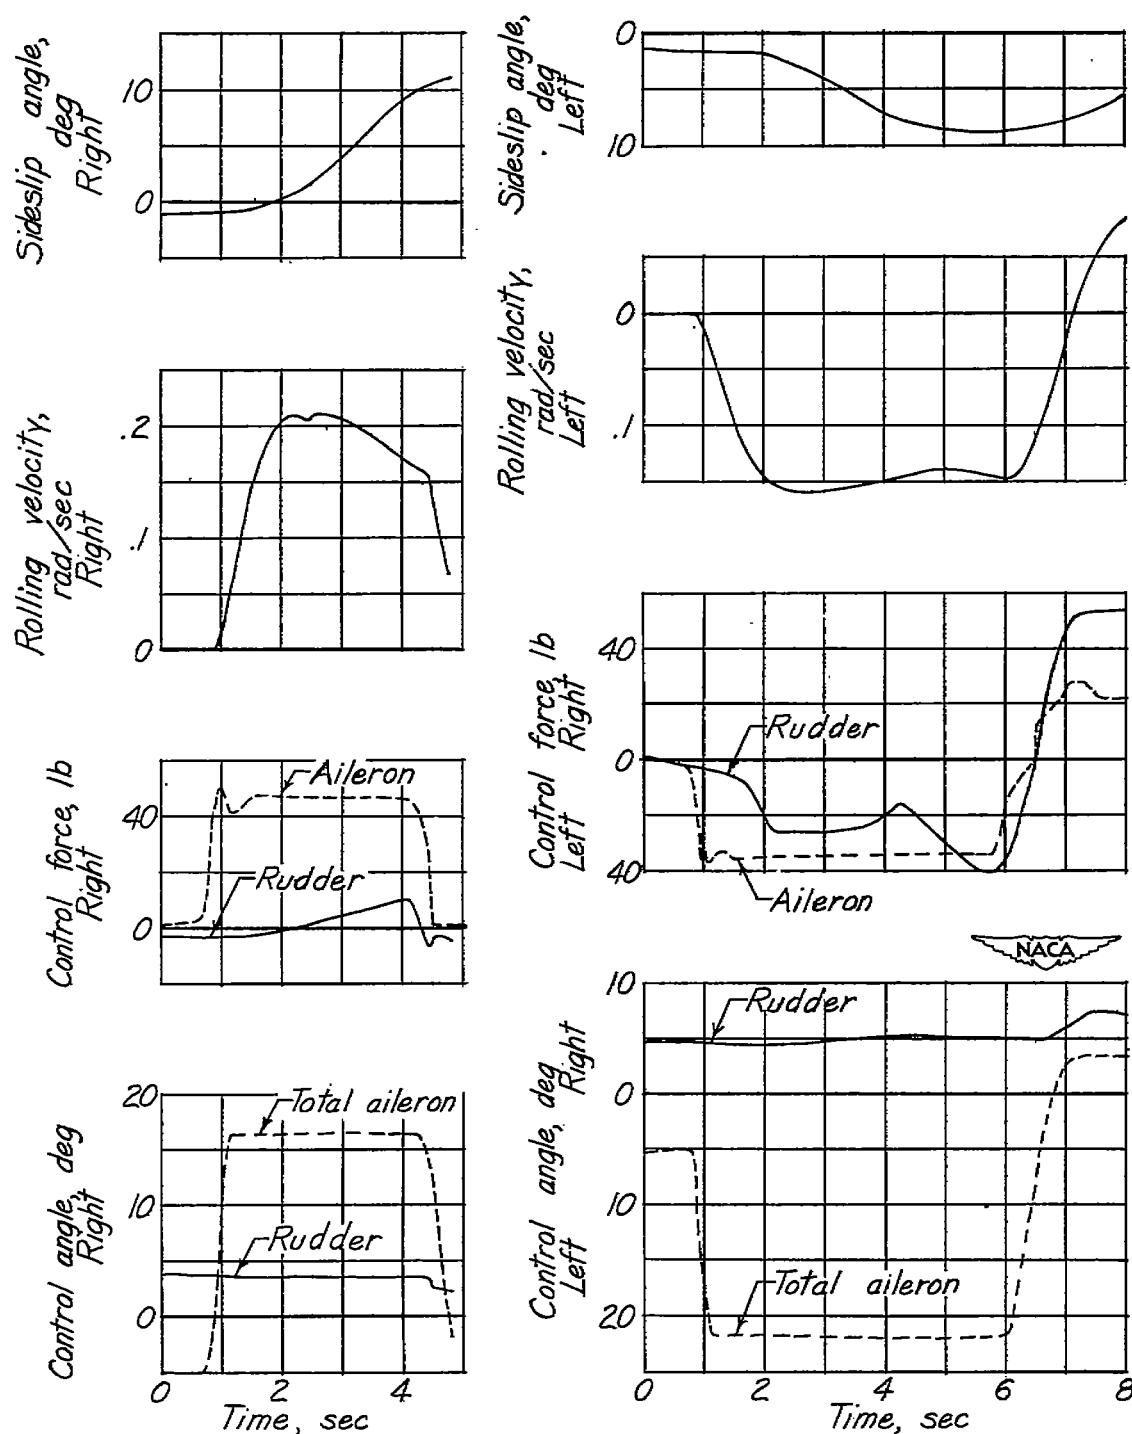
Figure 22.— Time histories of rudder fixed aileron rolls. C-54D airplane; clean condition; power for level flight; 120 miles per hour.

The power of the ailerons was tested by making abrupt rolls from straight flight with the rudder held in its trim position. Time histories of typical aileron rolls are presented in figure 22.

Rolling acceleration.— The time histories show that the rolling acceleration is in the correct direction and that the peak rolling acceleration occurs less than 0.3 second after the maximum aileron deflection is reached. Therefore, the requirements are satisfied.

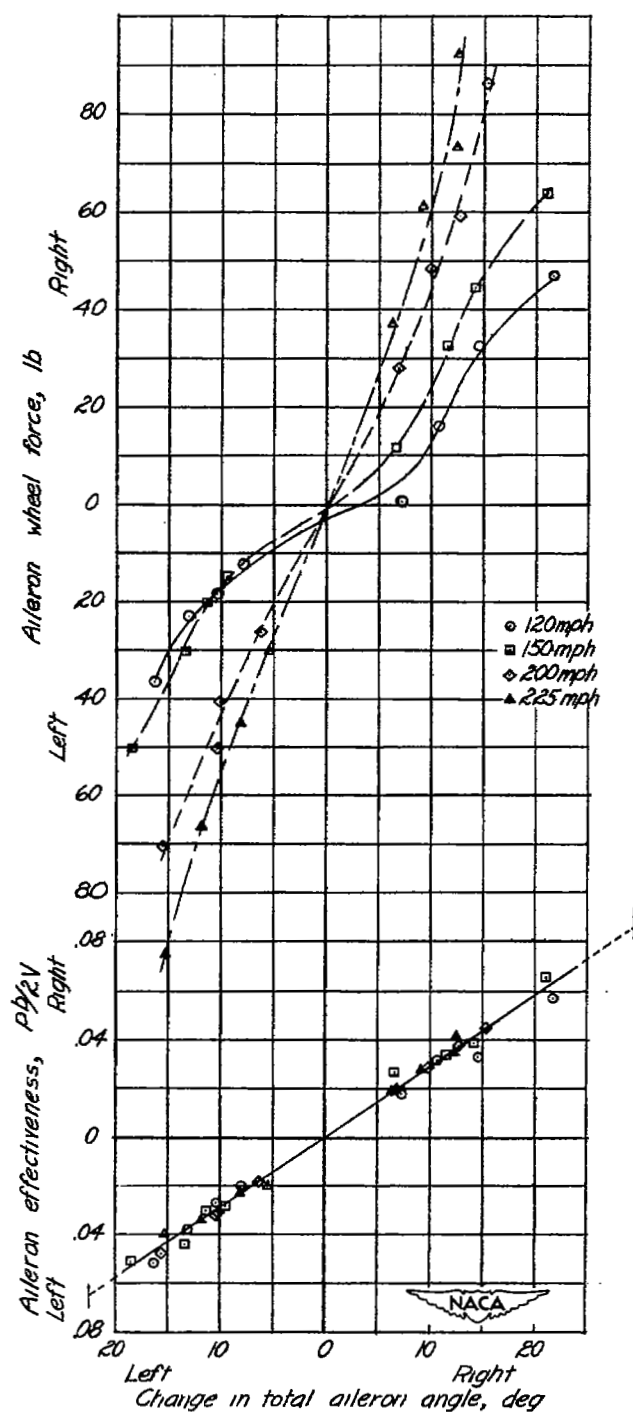
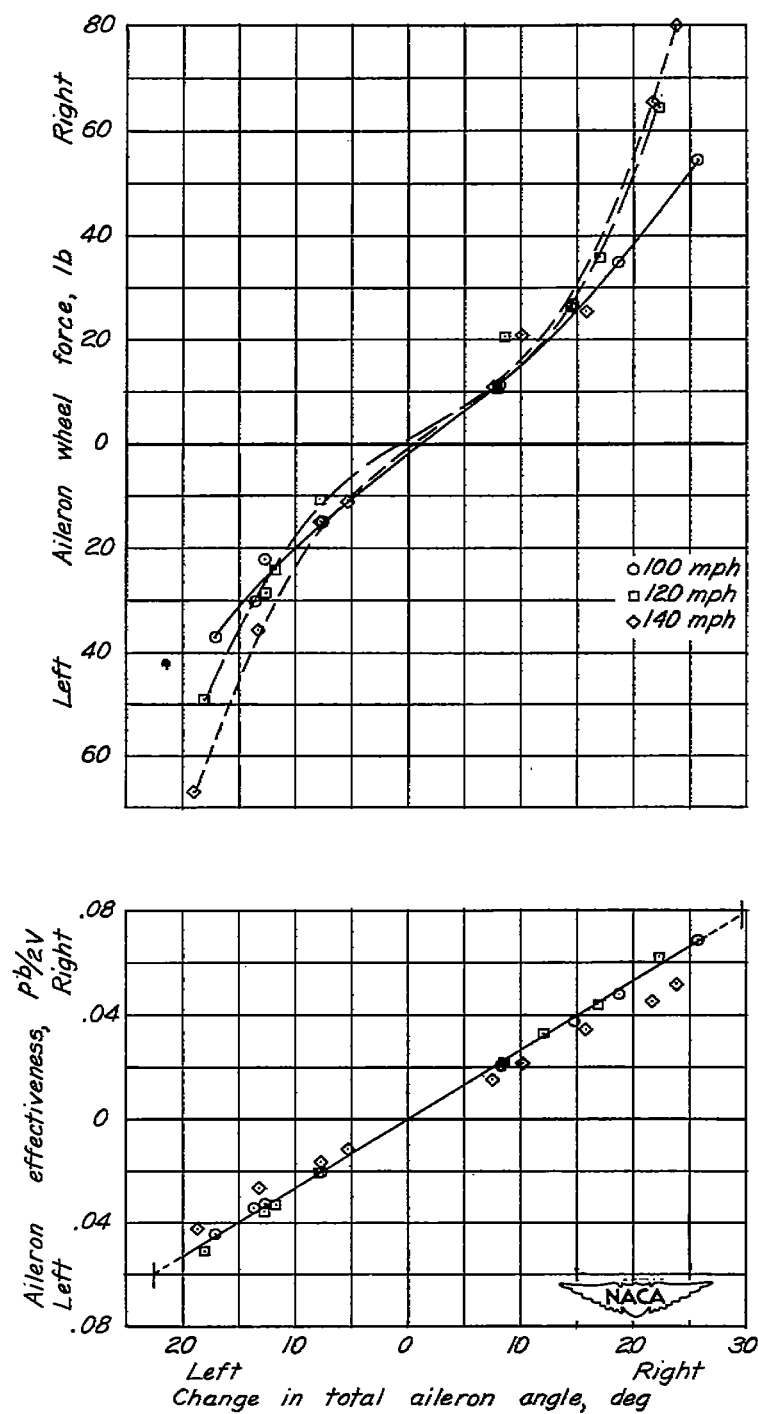
Figure 23.— Variation of aileron wheel force and aileron effectiveness parameter with change in total aileron angle at various speeds. C-54D airplane.

This airplane trimmed in steady flight with approximately $3\frac{1}{2}^\circ$ left aileron in most conditions. This was apparently due to some twist in the wing and would not be representative of all C-54 airplanes. Since the total aileron angle was restricted to 26° left and right, there was a greater change in total aileron angle available to the right than to the left. Consequently, with full aileron a greater $pb/2V$ was measured to the right than to the left. The maximum $pb/2V$ available to the left was 0.065 in the clean condition, 0.059 in the flaps full-down condition if extrapolated to full aileron deflection. The requirement that a minimum $pb/2V$ of 0.07 be available is not satisfied. Had the airplane trimmed with the aileron in neutral the value of $pb/2V$ would have been 0.076 in the clean condition and 0.069 in the approach condition.

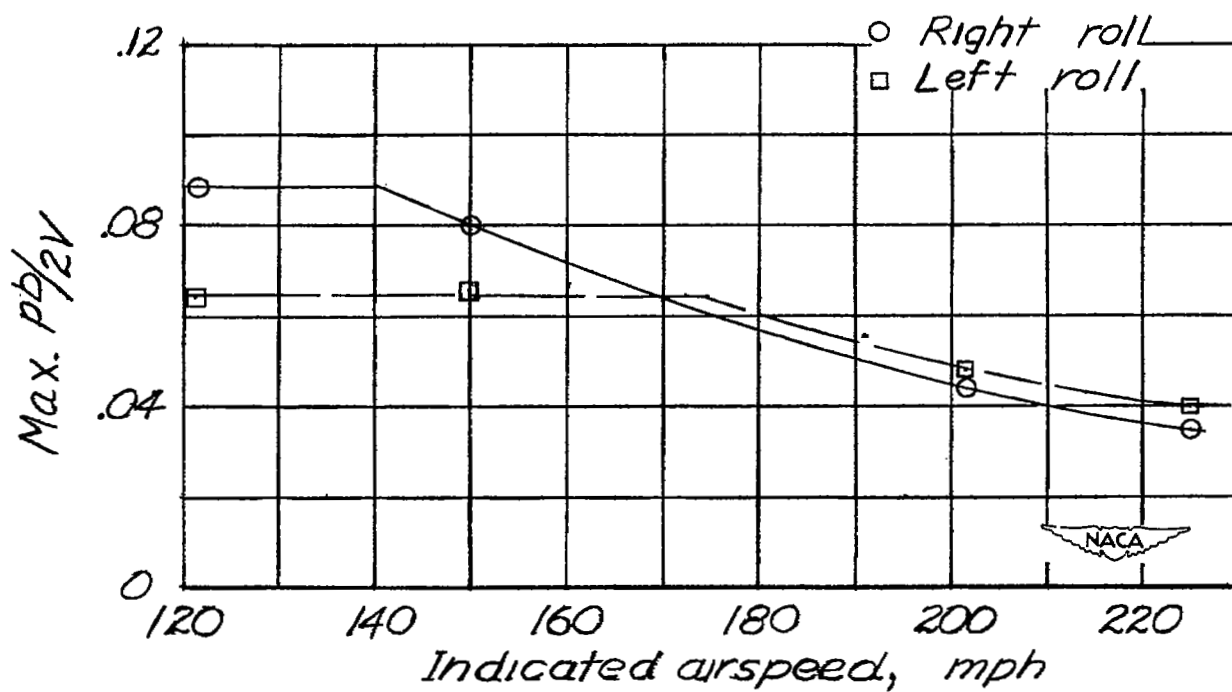
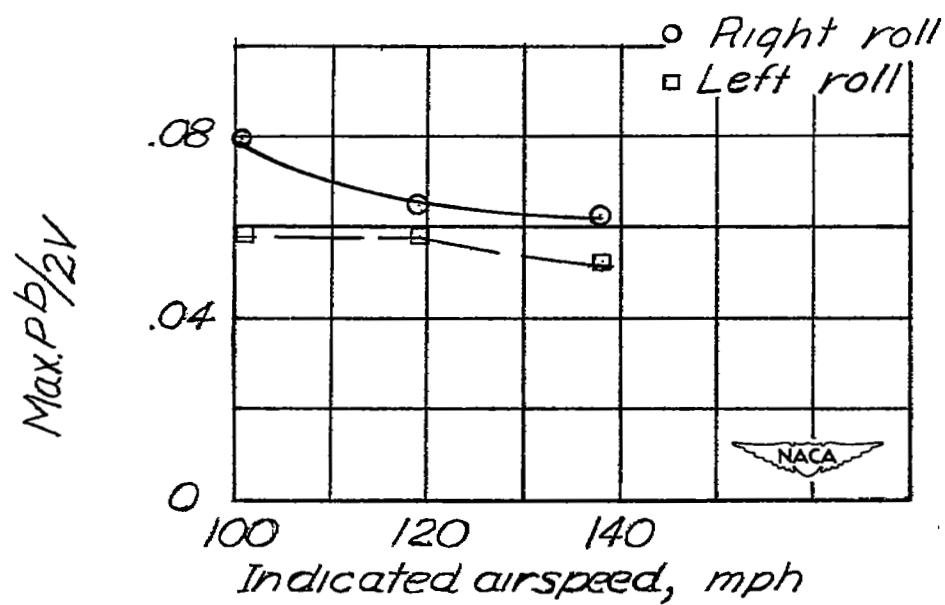
Figure 24.— Variation of maximum $pb/2V$ available without exceeding 80 pounds of wheel force with indicated airspeed. C-54D airplane.

The aileron control forces to obtain the maximum $pb/2V$ of 0.065 in the clean condition was in excess of 80 pounds above speeds 175 miles per hour. In the flaps-down, gear-down condition, the wheel force to obtain the maximum $pb/2V$ exceeded 80 pounds at all test speeds except the lowest (100 miles per hour). Figure 24 shows the maximum $pb/2V$ available at various speeds without exceeding 80 pounds wheel force in both the clean and the flaps-down, gear-down conditions. In the flaps-down, gear-down condition, a $pb/2V$ in excess of 0.05 is available at all speeds below 140 miles per hour. Therefore, the requirement that the ailerons given a $pb/2V$ of at least 0.05 at speeds of 1.1 to 1.5 V_S in the landing condition is satisfied.
